URBAN RIVERS, BAHIA'S WATERS

Nayara Cristina Rosa Amorim

ABSTRACT

Paisag. Ambiente: Ensaios, São Paulo, v. 30, n. 44, e160216, 2019.

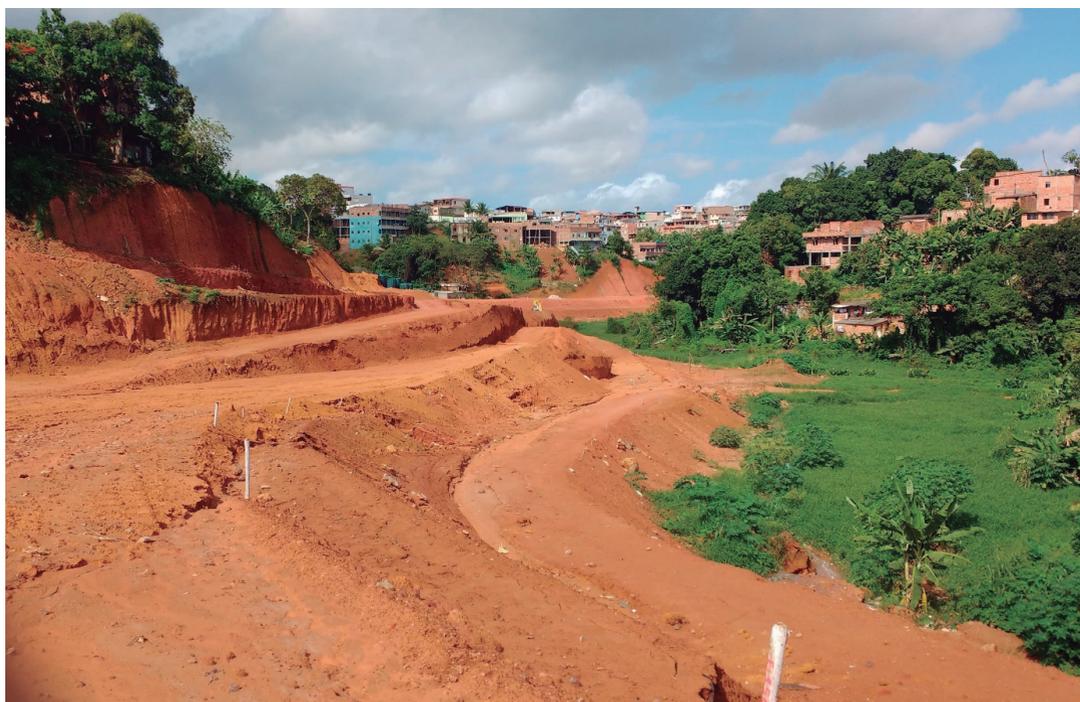
Figure 1: Construction of the Mário Sérgio Avenue on the Mocambo River PPA, with floodplain on the right side.
Photo: Nayara Amorim, March 2017.

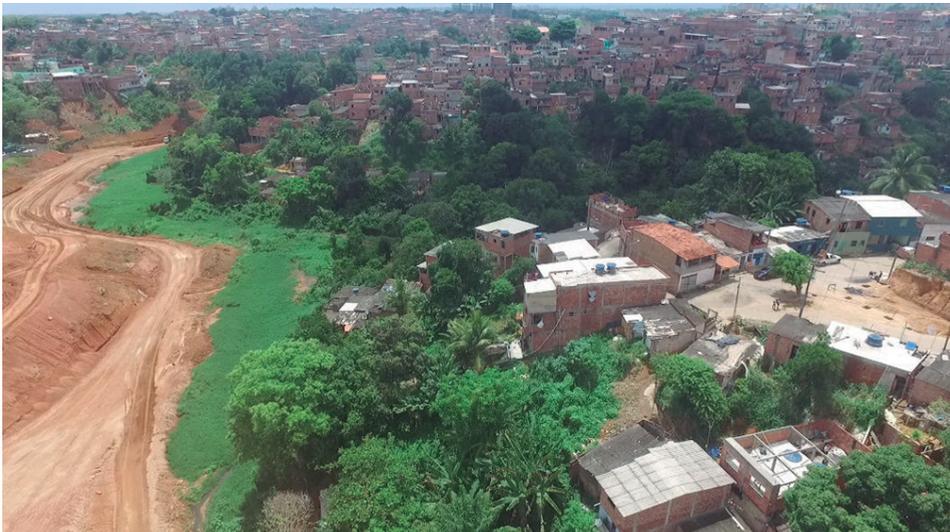
Figure 3: Stretch II, right bank of the Mocambo River during construction of the road. In the floodplain, the vegetation composed of grasses and herbaceous that cover the water layer and, in the background, in the more inclined areas, large vegetation and the neighborhood of Canabrava. Photo: Canabrava Community Cultural and Sports Association, March 2017.

Due to the characteristics of the species removed (P5), it is possible to identify part of the probable fauna present in the ecosystem, mainly birds, bees and pollinating insects, as well as some fruit species, such as jackfruit, mango and murici. According to residents' reports and on-site observations, residents near the river also planted avocados, banana trees and cocoa. It is customary, especially for children, to collect these fruits, which shows the provision of food by the local flora. Figure 3 illustrates one of the areas where fruit is still planted.

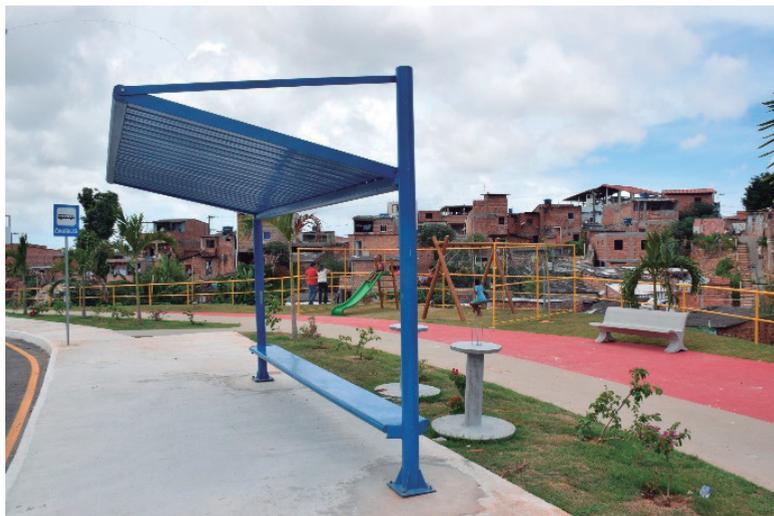
Figure 4: Bus stop, with bike path and leisure equipment in the background.
Photo: Thiago Jr., February 2018.

square of the Araújo Martins lane (approximately 80 m²). Equally the result of the claims are the bicycle paths on both sides of the track (l = 1 m), three bus stops (Figure 4), two staircases and some bridges over the Mocambo River (Figure 5), which connect residents to the new road. The Pôr do Sol (Sunset) Square was also built, which has a sand court, gym equipment and children's toys (approximately 4 thousand square meters), which, however, is not within the study area, as it is about three hundred distant meters.

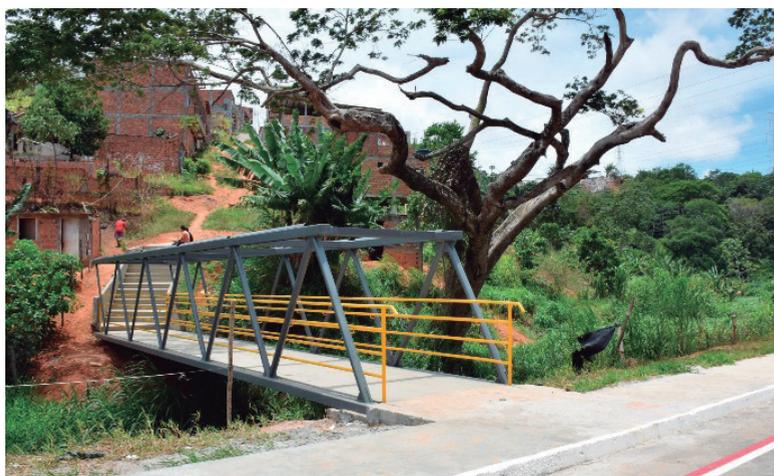
Figure 5: In the foreground, the line that marks the bike path, the bridge over the Mocambo River and the access staircase.
Photos: Thiago Jr., February 2018.
