ARCHITECTURE, MATTER, AND HISTORIOGRAPHY:
INTERFACES BETWEEN TECHNOLOGICAL INVESTIGATION
AND HISTORICAL RESEARCH BASED ON CERAMIC
BRICKS IN THE CITY OF SANTA LEOPOLDINA [ES]

Pós, Rev. Programa Pós-Grad. Arquit. Urban. FAUUSP. São Paulo, v. 24, n. 44, p. 148-163, set-dez 2017

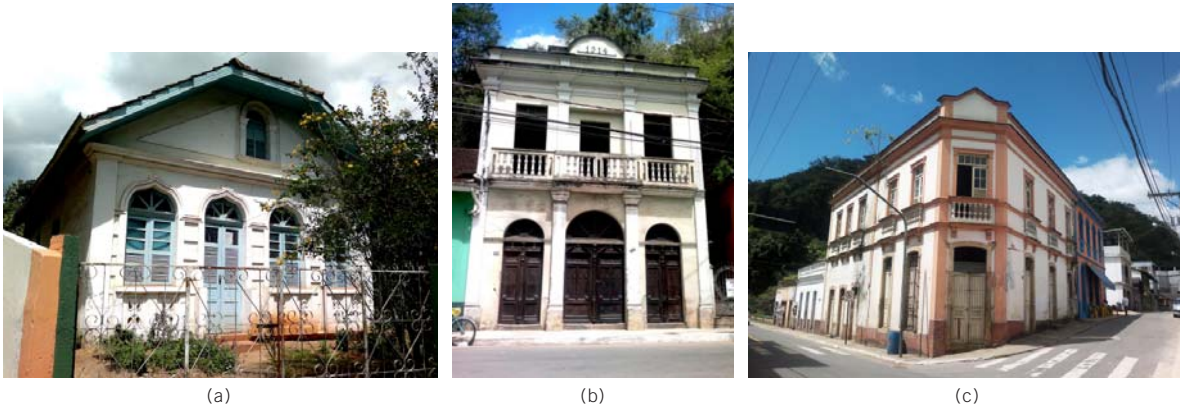
The buildings are located on the same street and at some points the constructive system is exposed, allowing for the collection of the ceramic brick samples (Figure 2).

Figure 2: Research buildings – (a) Building 1; (b) Building 2; (c) Building 3.
Source: Authors (2016).

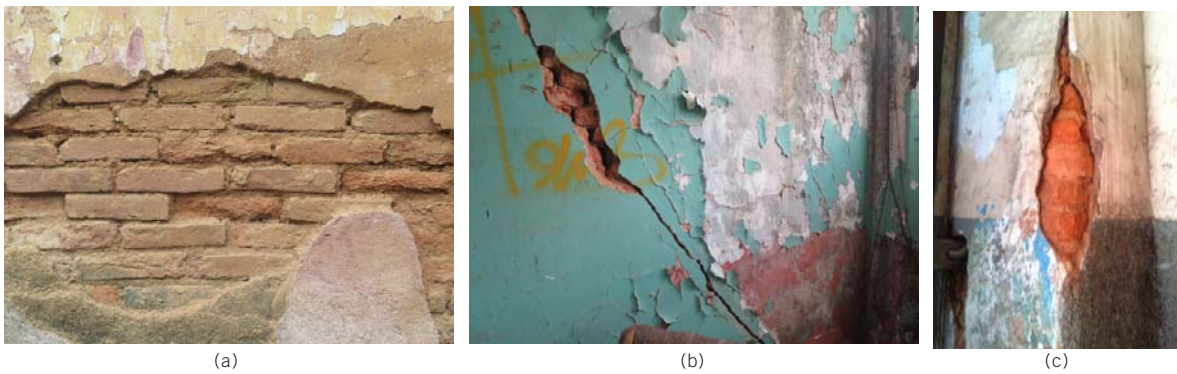
Coloring: samples from Building 1 have lighter shades, which may indicate a lesser degree of burning as well as lower iron oxide content (Fe₂O₃). In contrast, Building 2 shows bricks of a more reddish color. The bricks from Building 3 are similar to those of Building 2, but with an even more reddish tone (Figure 4).

Figure 4: (a) Building 1; (b) Building 2; (c) Building 3.
Source: Authors (2016).

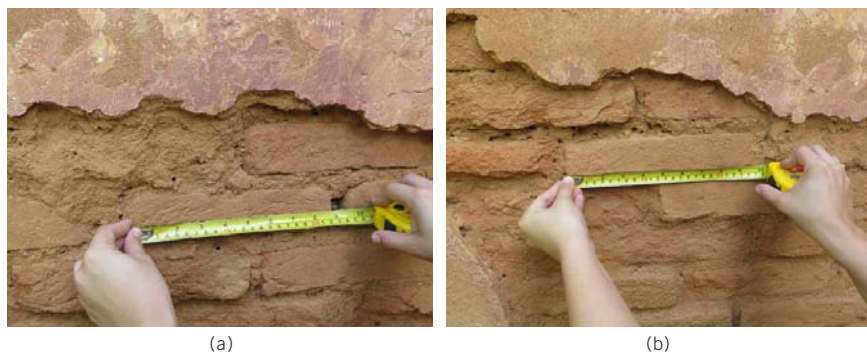
The macroscopic analysis also shows differences in the sizes of the samples, even among bricks laid in the same building, such as in Building 1. In the areas where bricks are exposed, variation ranges from 1 to 2 cm in length and

Figure 5 (a) and (b):
Comparison between bricks
laid in the masonry of the
back facade of Building 1.
Source: Authors (2016).

in height (Figure 5). From the sampling we were able to verify bricks with dimensions ranging from 21 to 26 cm in length, 13 to 15 cm in width, and 5 to 7 cm in thickness.

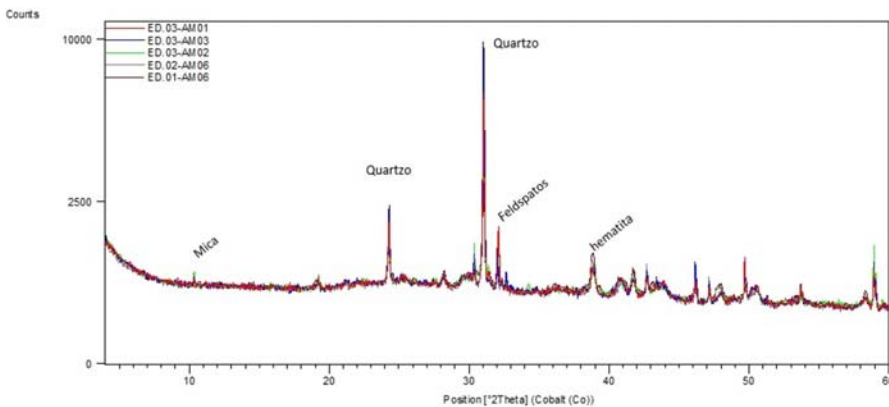
Group 03

Figure 8: Diffractogram samples Group 3.
Source: Authors (2016).

The samples from this group refer to Building 1 (AM06), Building 2 (AM06), and all the samples from Building 3 (AM01, AM02 and AM03) (Figure 8). The composition of the samples is quite similar, with the presence of quartz, feldspar and to a lesser extent mica and hematite, and the absence of clay minerals.

the samples were not calcined. In Group 3 there are samples similar to those of Buildings 1, 2 and 3, with burning temperatures above 550°C, and the absence of clay minerals.
